FIELD SUMMARY REPORT
REMEDIAL INVESTIGATION FIELD SAMPLING ACTIVITIES

FIELD SUMMARY REPORT REMEDIAL INVESTIGATION SAMPLING ACTIVITIES IR SITE 2, WEST BEACH LANDFILL AND WETLANDS ALAMEDA POINT, CALIFORNIA

Contract No. N68711-01-D-6009 Task Order No. 0007 Project No. G601507

May 24, 2005

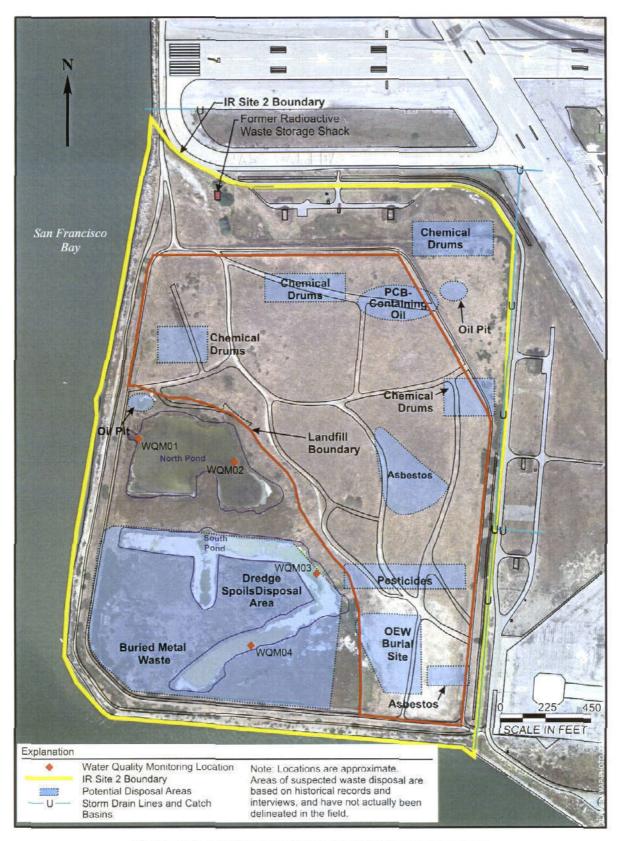
Figure B-3. IR Site 2 RI Water Quality Meter Locations

During each servicing and recalibration event, data were downloaded onto field computers and subsequently transferred to offsite data storage systems. Servicing was performed on August 11, September 30, and December 21, 2004; and January 26, 2005.

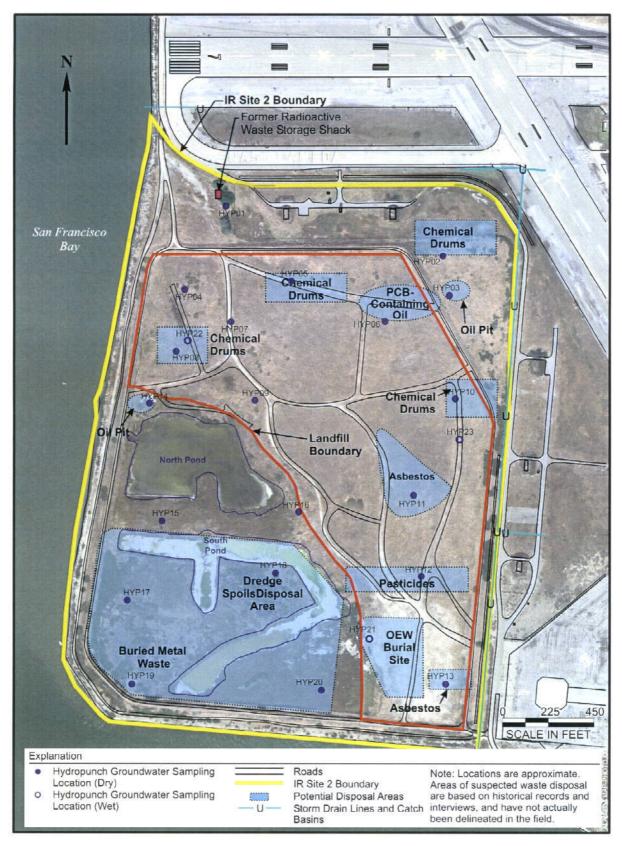
Figure B-7. IR Site 2 RI Groundwater Sample Locations

Groundwater samples were collected across the landfill to identify potential contaminant source zones and to assist with evaluating contaminant transport in the aqueous phase. Similar to soil samples, the groundwater sampling locations were biased towards areas of suspected contamination (e.g., potential drum disposal areas and oil sumps). A total of 13 temporary groundwater monitoring wells (HYP01-HYP13) were sampled between October 18 and 21, 2004 within the landfill and interior margin portions of IR Site 2, as depicted in Figure B-7. Temporary well casings were installed within the same borings that soil samples were collected. After soil samples had been collected to the top of the water table, the Geoprobe® continued to advance approximately 5 ft beyond the groundwater surface. All Geoprobe® rods were extracted and a temporary 1-inch diameter schedule-40 polyvinyl chloride (PVC) casing with a 5-ft screen at the bottom was set within the borehole. The casing was capped and allowed to settle while groundwater levels equilibrated. Although all groundwater sampling locations corresponded with a soil sample location, the HYP locations were surveyed using a hand-held Trimble Geoexplorer® GeoXTTM GPS unit. The NAD 27 coordinates for all dry season landfill and interior margin area groundwater sampling locations are tabulated in Table B-1.

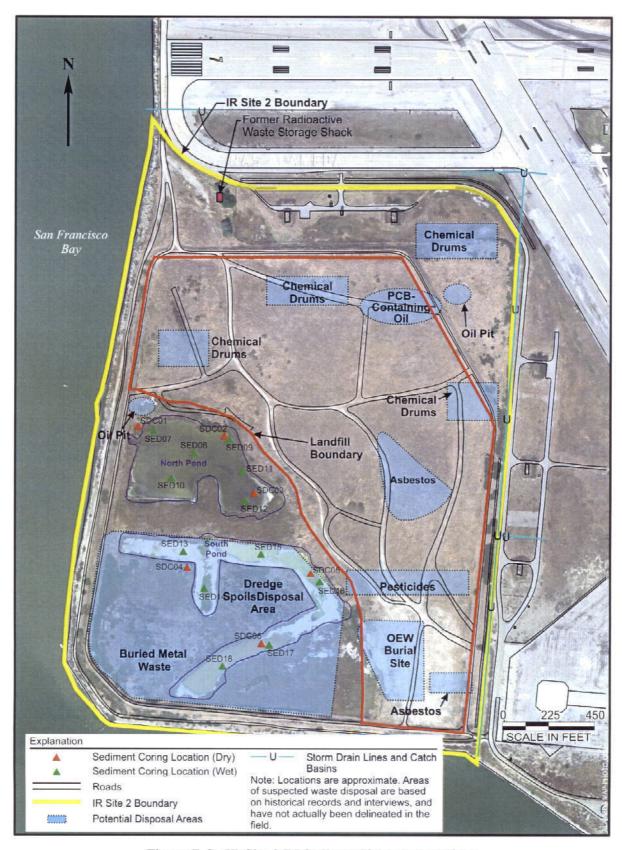
Figure B-8. IR Site 2 RI Sediment Sample Locations

Sediment cores were collected from discrete locations in the North Pond and the South Pond during the dry season sampling event. The sediment cores were completed in the area around the perimeter of the wetland ponds that is not inundated (but showed evidence of being seasonally inundated). A total of 6 sediment cores were investigated using hand coring techniques in the IR Site 2 wetlands ponds on October 12 and 13, 2004 (see Figure B-8). Three of the dry season sediment cores were located in the area of the North Pond (SDC01-SDC03) and three were in the area of the South Pond (SDC04-SDC07). Sediment cores were collected by hand using 4-inch diameter aluminum tubing lined with cellulose acetate butyrate (CAB) tubing and fitted with a stainless steel cutting edge and core catcher. The coring assembly was advanced into the sediment to a depth of 36 inches by using a sledge hammer and then extracted and placed on a clean table for logging and processing. See photographs of the sediment coring activities in Attachment 3. The CAB liners were retrieved from the aluminum tube, and screening for organic vapors and radiation using a PID and Ludlum Model 3 survey meter, respectively. The findings from the field screening indicated that neither organic vapors nor radiation were detected above background levels in the field for all sediment sampling locations in the wetland ponds. The lithology of each core was logged and other pertinent observations (e.g., odor or color) were recorded. In general, the most common lithology observed in the North Pond sediment cores consisted of a black silty clay. In the South Pond, the most common lithology in the sediment cores was a black to gravish brown fine to medium grained sand with some silty clay. Hydrogen sulfide (H₂S) odors were observed in South Pond sediment samples, but not in the North Pond samples. Copies of boring logs for the dry season sediment cores collected from the wetland ponds are presented in Attachment 4-5.

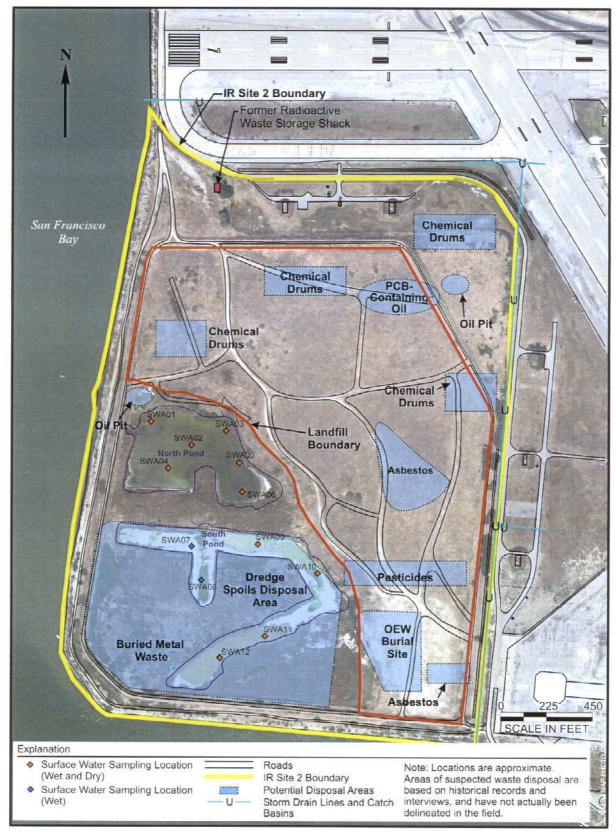
Figure B-9. IR Site 2 RI Surface Water Sample Locations

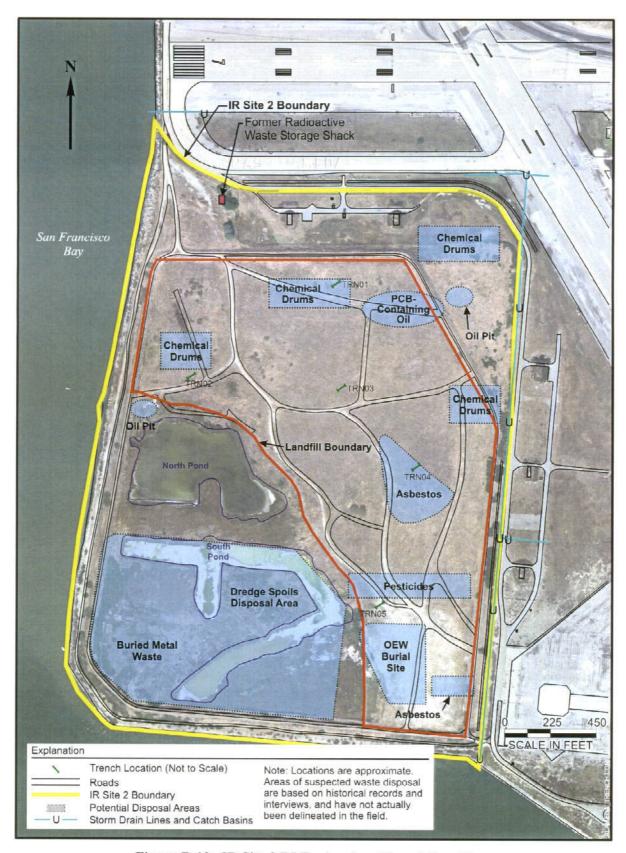
Figure B-10. IR Site 2 RI Exploratory Trench Locations

Five exploratory trenches (TRN01 to TRN05) were excavated on March 8 and 9, 2005 within the landfill area, focusing in areas that were considered likely to contain significant volumes of waste material based on geophysical survey results, analytical chemistry results from the dry season field sampling or historical sampling efforts, historical aerial photography, and/or historical information on site-specific disposal practices. The purpose of the trenches was to characterize the nature, type, and condition of the waste disposed at the site, and to determine the typical depth of waste placement. The five trenching locations are shown on Figure B-10.

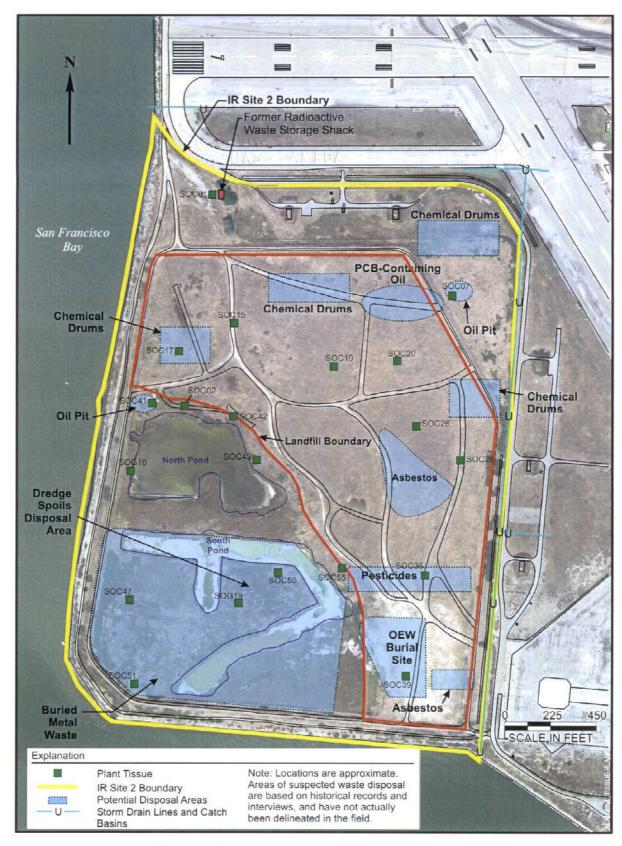
Figure B-11. IR Site 2 RI Tissue Sample Locations

Plant tissue samples were collected from 10 landfill (upland) locations at IR Site 2 to support the ecological risk assessment, as depicted in Figure B-11. The sampling locations were based on a preliminary review of the dry season surface soil data, and were chosen to provide tissues data from areas exhibiting chemical concentrations that were low, moderate and high relative to concentrations measured across the entire site. Table B-2 summarizes the locations where plant tissues were collected, the type of plants collected at each location, and the chemical analyses that were performed. Field personnel attempted to collect two plant species per site, with one single species representing a unique sample; however, some plants were difficult to identify in the field, hence all samples are not necessarily made up of one unique species. In general, grass tissue samples were chosen for upland locations due to their general ubiquity
